Habitats in the Santa Clara River

Channel Conditions Following Severe Flooding

Bank Stabilization, Typical Cross Section

Location of Long Canyon Road Bridge and Proposed Bank Stabilization Locations

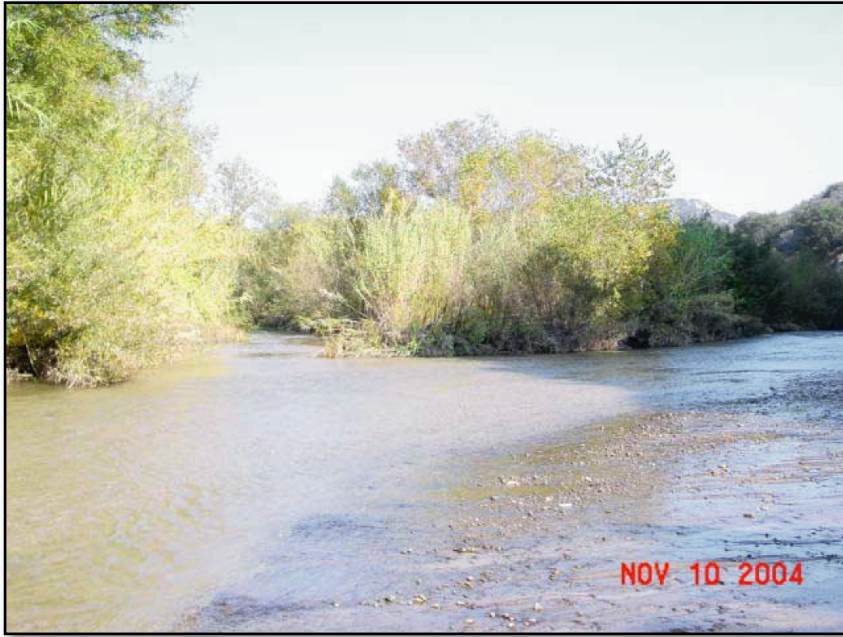
FIGURE 4.5-4

Castaic Creek/santa Clara River
Confluence Photographed in
November 2004
Prior to Winter 2005 Floods

Following a severe flood event in January 2005, ENTRIX biologists conducted a one-day reconnaissance survey of the project reach to evaluate the response of habitat conditions. Generally, plant and animal life had been flushed from the active stream channel. Riparian and aquatic vegetation along the stream margins had been scoured. Few or no aquatic insects were observed during numerous spot inspections. The streambed also aggraded in many areas, particularly in backwater pools where significant shallowing or complete filling had occurred. Significant deposition of sand and gravel was observed in the forms of lateral and mid-channel bars. Most exotic aquatic species appeared to have been flushed out by the flooding events.

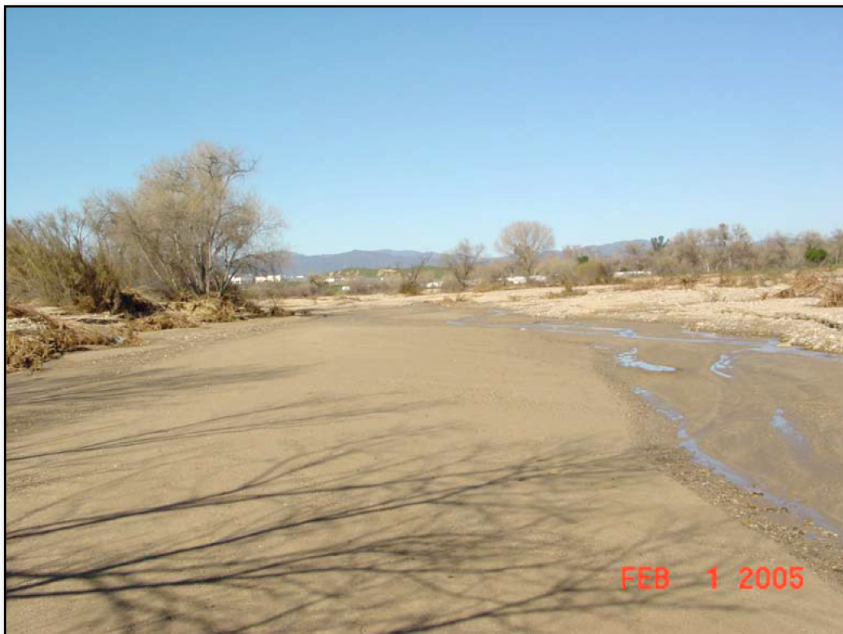
Castaic Creek Upstream of Confluence
Following January 2005 Flood
(Note Vegetation Scoured Throughout)
